## TEST REPORT

Report No.	: TC604223000000641F	Date:	11/01/2024
Job Reference	: 2114		
Name & address of client	: National High Speed Rail Corporation Limited (NHSRCL)		
Engineer	: TCAP		
Customer Sample Reference	: Rock Boulder (Fine Aggregate Wash Sand, Ultramold Sand) Source: Kanchad Wada Palghar M/s Skoop Dredging & De-silting Pvt Ltd RFI No. : 0000000748		
Project	: Design and Construction of 135.450 km Long Viaduct (MAHSR Ch. +21.150 km- +156.600 km) including 3 stations (Thane, Virar, Boisar), Tunnels, Earth Structures And Maintenance Depot for MAHSR Project		
Date of Sample Received	: 26/12/2023		
Description of sample	: Rock Boulder		
Duration of testing	: 08/01/2024 to 11/01/2024		
Test Method Followed	: As per IS-2386: Part VIII-1963 (Reaffirmed 2021)		
Discipline	: Mechanical		
Group	: Building Material

Approximately 15 Kg boulder sample was sent by M/s Kratos Concrete, Thane to Advanced Diagnostic Laboratory, Dr. Fixit Institute, Andheri (E), Mumbai for petrographic examination of rock boulders for aggregate as per IS 2386: Part VIII.

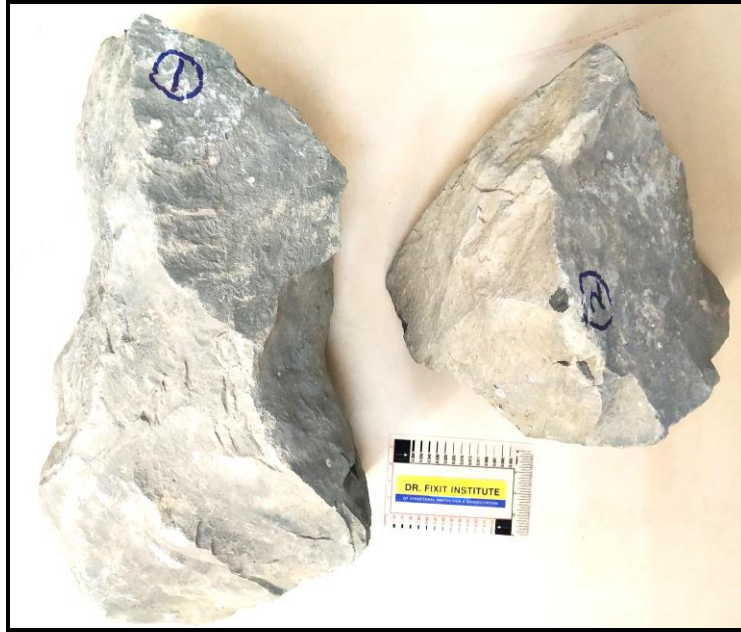
Rock boulders were observed to be dark grey coloured, fine grained, mafic volcanic igneous rock. The rock was identified to be basaltic rock. Rock particles were observed to be hard, mainly fresh to faintly weathered and dense. Surface texture was found to be crystalline (**Figure-1**). Any kind of organic coating was not

found in the particles. In the one boulder (boulder marked as -2 in Figure-1) minor calcite minerals were observed.

**Figure-1:** Photograph showing particles of rock boulders with crystalline surface texture

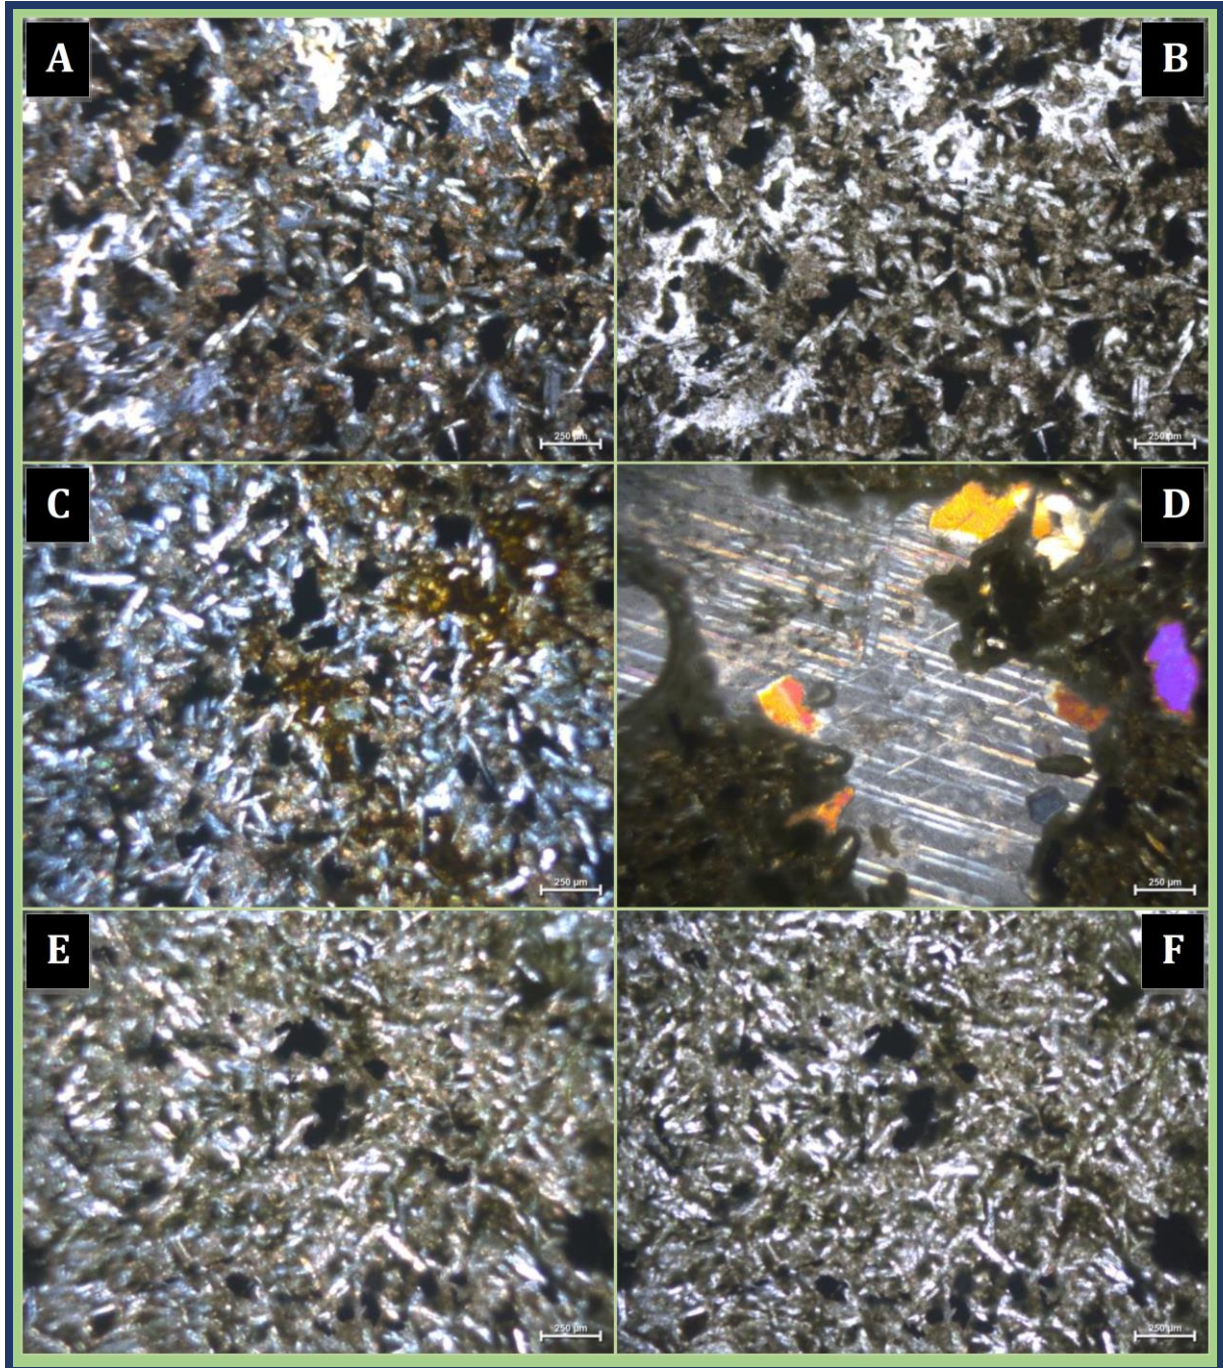
**Petrography of boulder-1:** This is fresh basaltic rock in which minerals were identified to be plagioclase feldspar, clinopyroxene, altered mafic and opaque minerals (**Figure-2 A to C**). In the groundmass, lath shaped multi-oriented plagioclase feldspar grains were found to be most abundant and found uniformly distributed throughout the groundmass of the basaltic rock. Condition of plagioclase feldspar grains were observed to be in slightly altered condition. Minor alteration was observed along the margins and cleavage planes of plagioclase feldspar grains.

Clinopyroxene grains were observed to be mostly in subhedral shaped and found uniformly distributed along with plagioclase feldspar. Condition of clinopyroxene grains were found to be mainly in slightly altered condition. Ophitic texture was commonly observed in the rock that is intergrowth texture between plagioclase and pyroxene.

Altered mafic grains were also observed in the rock. These grains were formed due to complete alteration of mafic grains particularly olivine grains were that were converted in chlorite grains. Opaque minerals were found cubic formed, randomly distributed throughout the rock. Grains were found to be mostly in slightly altered condition and mineral was identified to be iron oxide. Modal analysis of the groundmass of the rock is given **Table-1**.

**Petrography of Boulder-2:** In this rock boulder, in groundmass similar mineralogy and textural properties was found as in fresh basaltic rock (**Figure-2 D to F**). However, alteration in major minerals was observed more common than fresh rock boulder. Sericitization in plagioclase feldspar grains were commonly observed. Chloritization in the minerals were formed due to alteration of clinopyroxene minerals. Opaque minerals were minor and found mostly in altered condition. Minor calcite grains were also observed along the plagioclase phenocrysts as altered form. Plagioclase phenocrysts in the rock shows porphyritic texture. Modal analysis of the groundmass of the rock is given **Table-1**.

**Figure-2:** Photomicrographs of basaltic rock, **A to C)** Distribution of plagioclase feldspar, clinopyroxene, altered mafic and opaque minerals in the fresh basaltic rock (boulder-1) and **D to F)** Photomicrographs are showing Distribution of plagioclase feldspar, clinopyroxene, altered mafic and opaque minerals and plagioclase phenocrysts in the faintly weathered basaltic rock (boulder-2). (A, C, D, E & F: 5x, XPL and B: same photomicrograph as A in PPL). [XPL = Cross polarised light and PPL = Plane polarised light].
